**Asbestos Management Survey for**

Waterglade  
Woodchester Park  
Beaconsfield  
Buckinghamshire  
HP9 2RR

Project Number: 9970

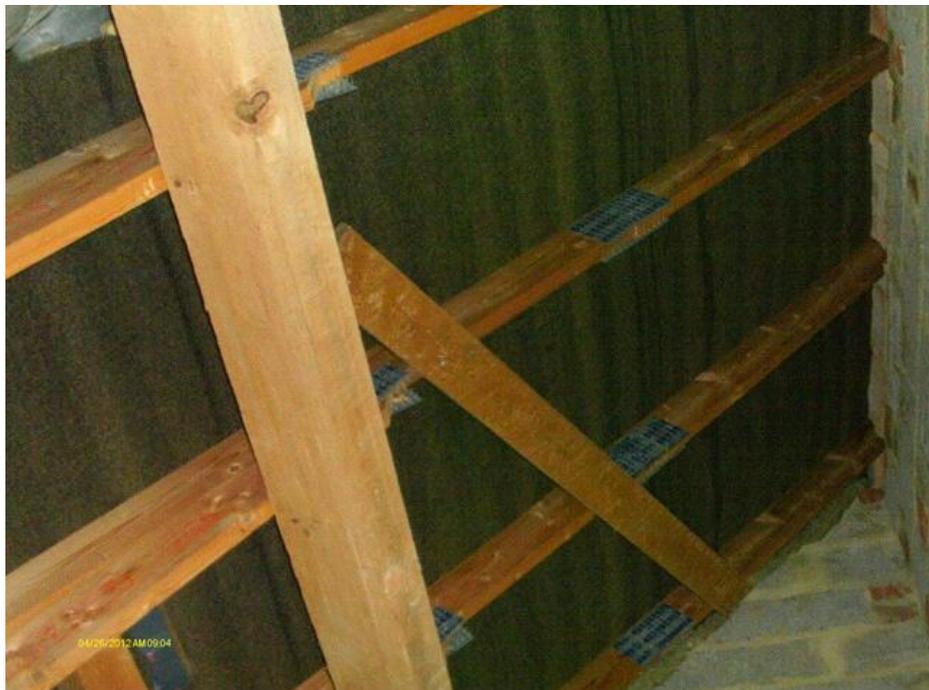
Location ID:	<input type="text" value="5423"/>	Survey Type:	<input type="text" value="MS"/>
Location Ref:	<input type="text" value="BS01"/>	Product Type:	<input type="text" value="NADIS"/>
Product:	<input type="text" value="Felt"/>	Damage:	<input type="text" value="NADIS"/>
Area:	<input type="text" value="Roof"/>	Treatment:	<input type="text" value="NADIS"/>
Floor:	<input type="text" value="Loft Space"/>	Asbestos Type:	<input type="text" value="NADIS"/>
Room:	<input type="text" value="Loft space"/>	Identification:	<input type="text" value="Identified"/>
Surveyor Name:	<input type="text" value="Peter Stevens"/>	Quantity:	<input type="text"/>
Drawing Ref:	<input type="text" value="9970/01"/>		
Asbestos ?	<input type="text" value="No"/>		
Date:	<input type="text" value="26 April 2012"/>		
Next Inspection:	<input type="text" value="Not Applicable"/>

Material Risk Score:	<input type="text" value="0"/>
Material Risk Band:	<input type="text" value="NADIS"/>
Priority Risk Score:	<input type="text" value="N/A"/>

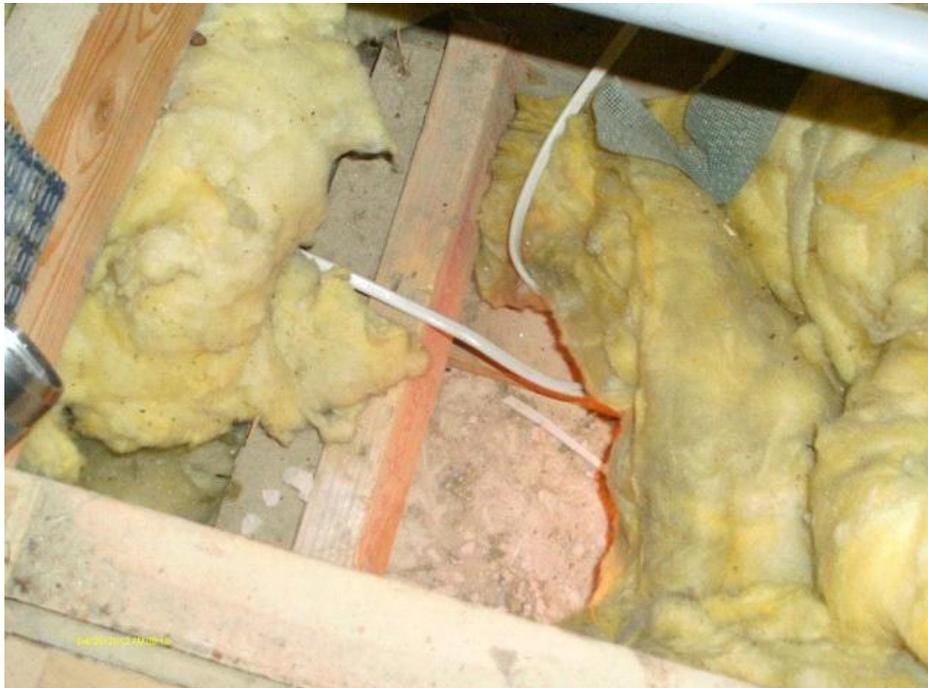
Location ID:	<input type="text" value="5424"/>	Survey Type:	<input type="text" value="MS"/>
Location Ref:	<input type="text" value="BS02"/>	Product Type:	<input type="text" value="NADIS"/>
Product:	<input type="text" value="Dust and debris"/>	Damage:	<input type="text" value="NADIS"/>
Area:	<input type="text" value="Floor"/>	Treatment:	<input type="text" value="NADIS"/>
Floor:	<input type="text" value="Loft Space"/>	Asbestos Type:	<input type="text" value="NADIS"/>
Room:	<input type="text" value="Loft space"/>	Identification:	<input type="text" value="Identified"/>
Surveyor Name:	<input type="text" value="Peter Stevens"/>	Quantity:	<input type="text"/>
Drawing Ref:	<input type="text" value="9970/01"/>		
Asbestos ?	<input type="text" value="No"/>		
Date:	<input type="text" value="26 April 2012"/>		
Next Inspection:	<input type="text" value="Not Applicable"/>

Material Risk Score:	<input type="text" value="0"/>
Material Risk Band:	<input type="text" value="NADIS"/>
Priority Risk Score:	<input type="text" value="N/A"/>

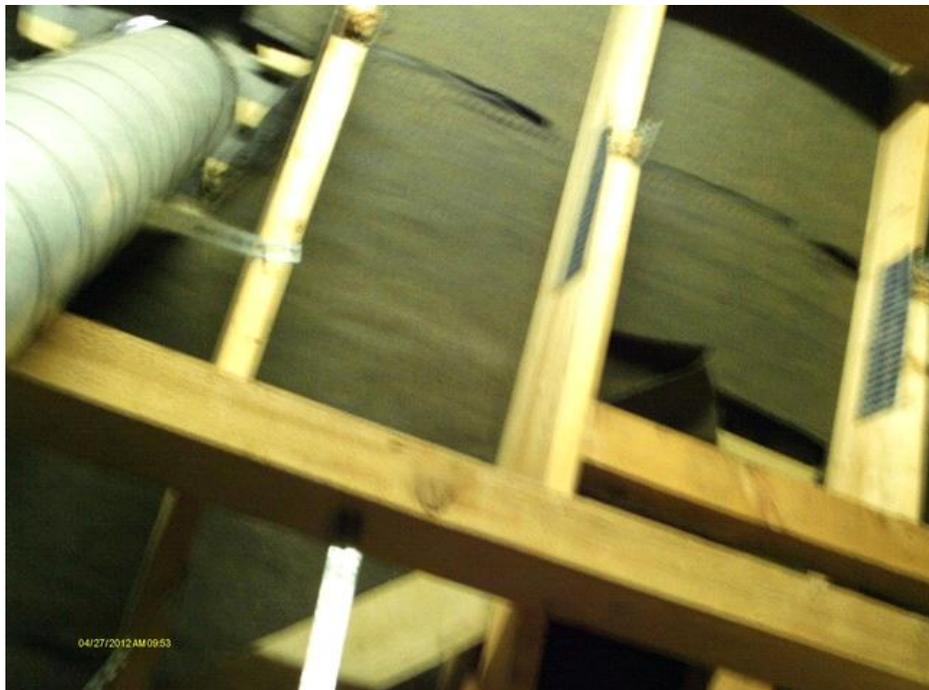
Location ID:	<input type="text" value="5425"/>	Survey Type:	<input type="text" value="MS"/>
Location Ref:	<input type="text" value="BS03"/>	Product Type:	<input type="text" value="NADIS"/>
Product:	<input type="text" value="Felt"/>	Damage:	<input type="text" value="NADIS"/>
Area:	<input type="text" value="Roof"/>	Treatment:	<input type="text" value="NADIS"/>
Floor:	<input type="text" value="Loft Space"/>	Asbestos Type:	<input type="text" value="NADIS"/>
Room:	<input type="text" value="Loft space"/>	Identification:	<input type="text" value="Identified"/>
Surveyor Name:	<input type="text" value="Peter Stevens"/>	Quantity:	<input type="text"/>
Drawing Ref:	<input type="text" value="9970/01"/>		
Asbestos ?	<input type="text" value="No"/>		
Date:	<input type="text" value="06 April 2012"/>		
Next Inspection:	<input type="text" value="Not Applicable"/>

Material Risk Score:	<input type="text" value="0"/>
Material Risk Band:	<input type="text" value="NADIS"/>
Priority Risk Score:	<input type="text" value="N/A"/>

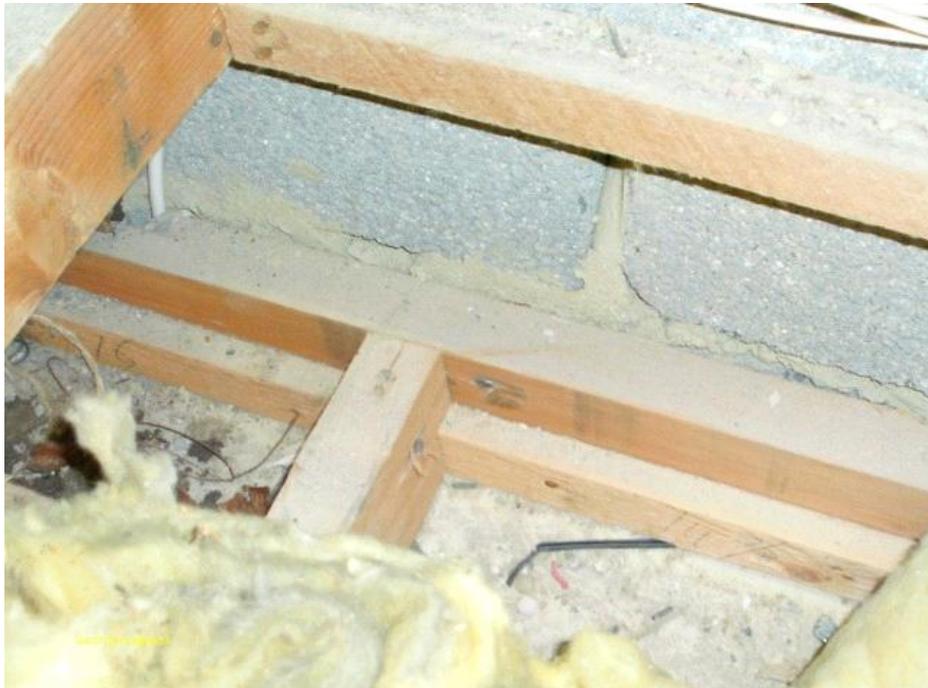
Location ID:	<input type="text" value="5426"/>	Survey Type:	<input type="text" value="MS"/>
Location Ref:	<input type="text" value="BS04"/>	Product Type:	<input type="text" value="NADIS"/>
Product:	<input type="text" value="Dust and debris"/>	Damage:	<input type="text" value="NADIS"/>
Area:	<input type="text" value="Floor"/>	Treatment:	<input type="text" value="NADIS"/>
Floor:	<input type="text" value="1st Floor"/>	Asbestos Type:	<input type="text" value="NADIS"/>
Room:	<input type="text" value="Loft space"/>	Identification:	<input type="text" value="Identified"/>
Surveyor Name:	<input type="text" value="Peter Stevens"/>	Quantity:	<input type="text"/>
Drawing Ref:	<input type="text" value="9970/01"/>		
Asbestos ?	<input type="text" value="No"/>		
Date:	<input type="text" value="26 April 2012"/>		
Next Inspection:	<input type="text" value="Not Applicable"/>

Material Risk Score:	<input type="text" value="0"/>
Material Risk Band:	<input type="text" value="NADIS"/>
Priority Risk Score:	<input type="text" value="N/A"/>

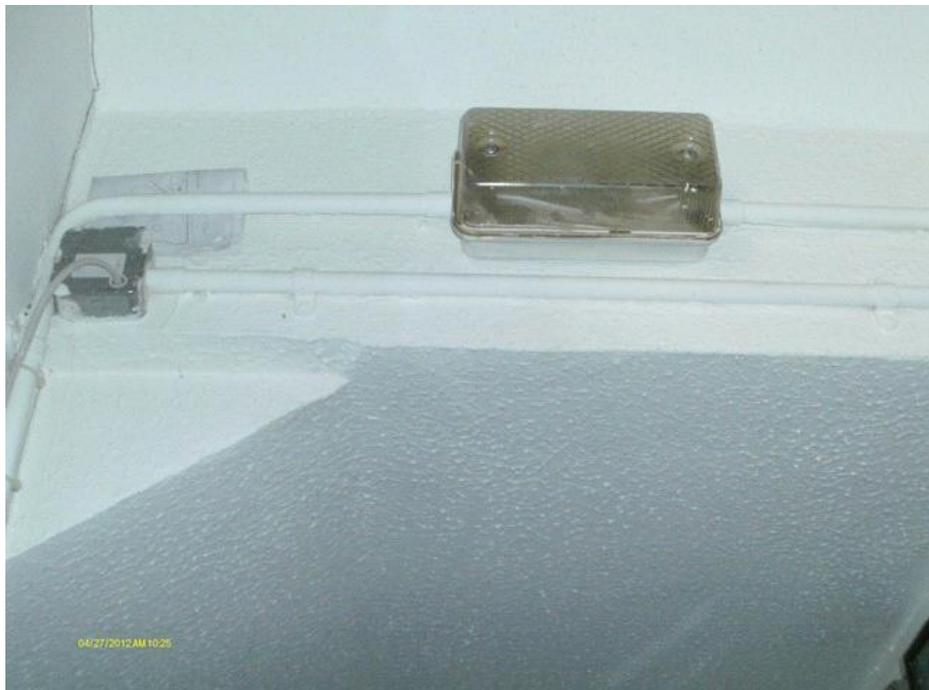
Location ID:	<input type="text" value="5427"/>	Survey Type:	<input type="text" value="MS"/>
Location Ref:	<input type="text" value="BS05"/>	Product Type:	<input type="text" value="NADIS"/>
Product:	<input type="text" value="Textured coating"/>	Damage:	<input type="text" value="NADIS"/>
Area:	<input type="text" value="Ceiling"/>	Treatment:	<input type="text" value="NADIS"/>
Floor:	<input type="text" value="Ground"/>	Asbestos Type:	<input type="text" value="NADIS"/>
Room:	<input type="text" value="Electric Cupboard"/>	Identification:	<input type="text" value="Identified"/>
Surveyor Name:	<input type="text" value="Peter Stevens"/>	Quantity:	<input type="text"/>
Drawing Ref:	<input type="text" value="9970/01"/>		
Asbestos ?	<input type="text" value="No"/>		
Date:	<input type="text" value="26 April 2012"/>		
Next Inspection:	<input type="text" value="Not Applicable"/>

Material Risk Score:	<input type="text" value="0"/>
Material Risk Band:	<input type="text" value="NADIS"/>
Priority Risk Score:	<input type="text" value="N/A"/>

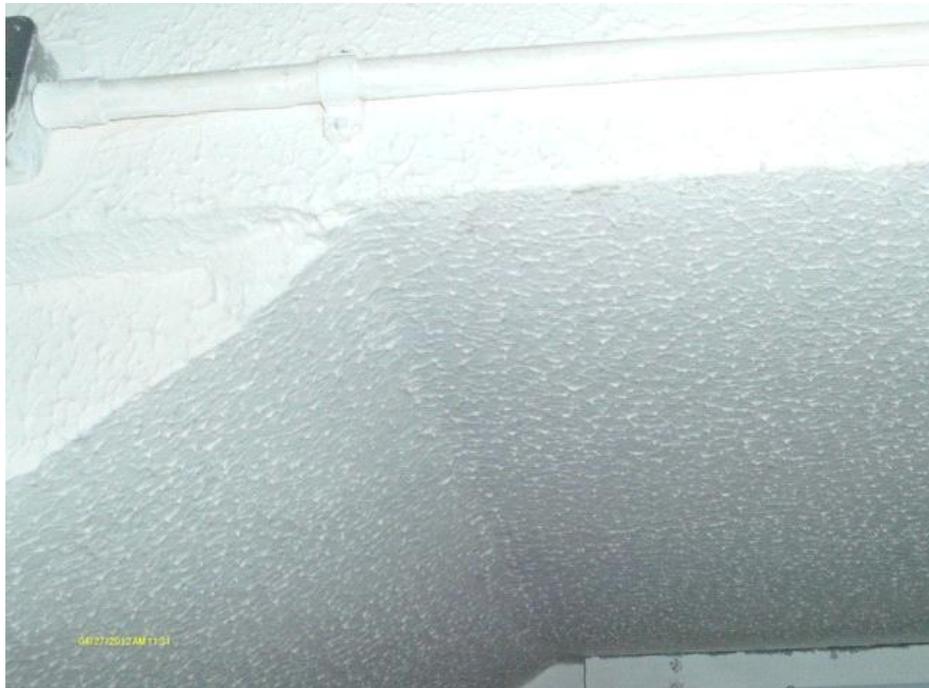
Location ID:	<input type="text" value="5428"/>	Survey Type:	<input type="text" value="MS"/>
Location Ref:	<input type="text" value="BS06"/>	Product Type:	<input type="text" value="NADIS"/>
Product:	<input type="text" value="Textured coating"/>	Damage:	<input type="text" value="NADIS"/>
Area:	<input type="text" value="Ceiling"/>	Treatment:	<input type="text" value="NADIS"/>
Floor:	<input type="text" value="Ground"/>	Asbestos Type:	<input type="text" value="NADIS"/>
Room:	<input type="text" value="Electric Cupboard"/>	Identification:	<input type="text" value="Identified"/>
Surveyor Name:	<input type="text" value="Peter Stevens"/>	Quantity:	<input type="text"/>
Drawing Ref:	<input type="text" value="9970/01"/>		
Asbestos ?	<input type="text" value="No"/>		
Date:	<input type="text" value="06 April 2012"/>		
Next Inspection:	<input type="text" value="Not Applicable"/>

Material Risk Score:	<input type="text" value="0"/>
Material Risk Band:	<input type="text" value="NADIS"/>
Priority Risk Score:	<input type="text" value="N/A"/>
